Mechanical Soil Conservation with Contour Ridges: Cure for, or Cause of, Rill Erosion?

Jürgen Hagmann

Jürgen Hagmann (1996) "*Mechanical Soil Conservation with Contour Ridges: Cure for, or Cause of, Rill Erosion?*", in Land Degradation & Development, Wiley, ISSN 1085-3278

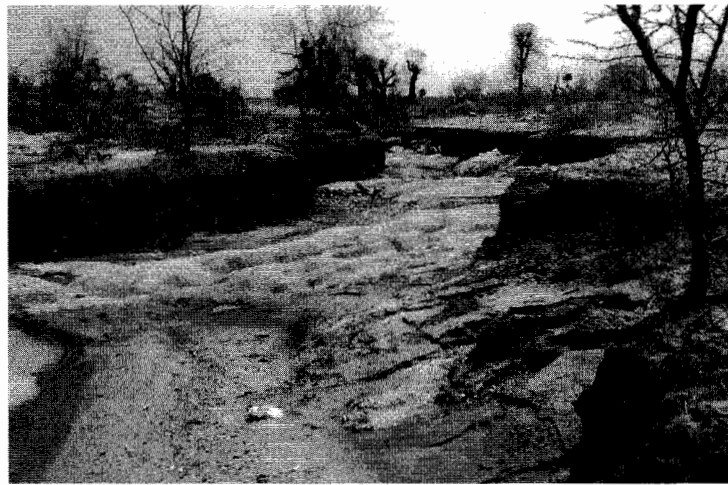
Figure 4. The gully at the valley bottom (bottom right in Figure 3) with excavated rocks and sand depositions

The deposition of eroded material was measured, and was related to the soil loss of the 1992/93 season. Soil was mainly eroded in the central and upper part of the slope in the fields, and was deposited at the bottom along the contour drain or silted up the contour drain (Figure 3). In 1992/93, 23.8 per cent of the eroded soil was identifiable as deposition in the field and in the contour drains (Table I). Some sand accumulated in a thin layer which could not be quantified, but most left the fields and the catchment because of broken or overflowing contour ridges and spilled into the gully at the valley bottom (Figure 4).

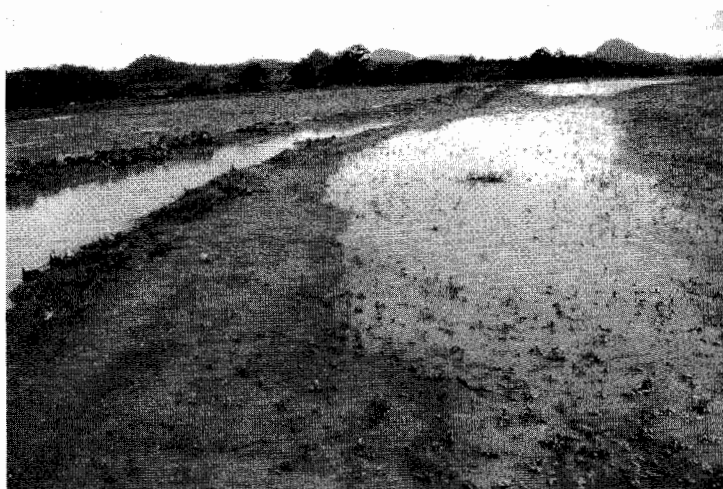
Figure 7. A second bund above the contour ridge creates a retention basin and prevents water and fine material from flowing straight into the contour drain

(c) The origin of the third category (runoff concentration in the fields) is solely surface runoff, sheet erosion and related tillage, as water from surface runoff is concentrated in depressions. These are often caused by continuously ploughing across the slope, throwing the soil towards the centre of the field. With time, this ploughing practice (gathering) changes the morphology of the field. A 'plough crest' is formed in the centre of the field, leaving a depression on either side. This also results in the formation of a bund before the actual contour drain at the downslope field margin (Figure 6), as farmers do not plough in the drain but leave some space between the drain and the cropped area. The two depressions, the one above the plough crest in particular, and the one above the contour drain, act like water-retention basins where fertile, fine material is deposited. Except during heavy storms, this morphology results in water retention and can be considered to be positive. However, serious damage can occur during heavy storms with substantial surface runoff, when the water in the basin spills out and cuts rills into the crest. Runoff concentration in the field was the prime origin of 36 rills (26.9 per cent), but caused only 4.7 per cent of the total soil loss and 7.8 per cent of the damaged area. The majority of those rills (66.7 per cent) were small rills which were mainly induced during the 1992/93 rainy season. Compared with the other two categories, the effect of water concentration in the field on rill erosion damage appears to be minor (Figure 7).

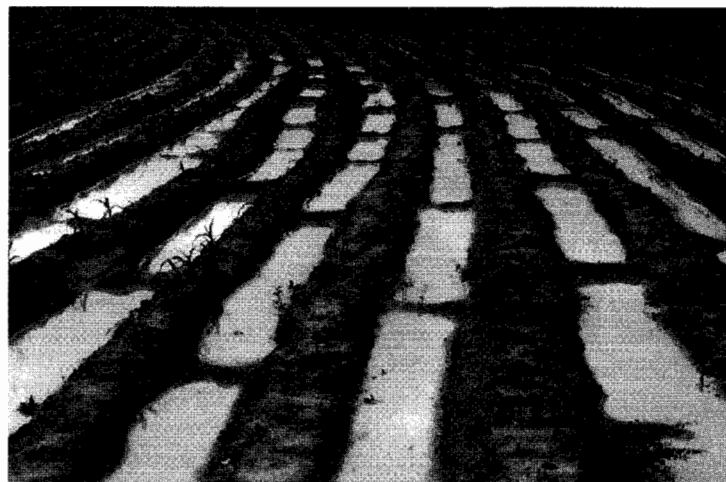
Figure 8. Tied-ridging retains water in the furrow basins during a rainstorm and reduces runoff and soil loss

Tied-ridging effectively protected the land from rill and sheet erosion, with less than 2 t ha⁻¹ soil loss in rills. However, if all the rills in tied-ridging are considered, including those caused by breakthrough of contour ridges and influx from outside, 5.9 t had been eroded in the entire tied-ridging field area. The total accumulated material was 12.3 t, which implies that a net accumulation occurred. Visual observations also confirmed that well-tied ridges were able to stop rills caused by break-in of water. The water and eroded material spilled into the furrows, which provided a retention volume (Figure 8).
